The Tale of Two Thru-Hulls

Jane Christen, AMS®

This is the story of two boats that heavily flooded and nearly sank resultant to thru-hull fittings that failed from dezincification. Michel & Christen Marine Loss/Damage Surveyors^{T1} attended the boat on the left in the following photos and tables, for an insurance company². Testing³ on the failed aft head thru-hull fitting was done, and it was discovered that this factory original fitting is an alloy of high zinc content Brass!

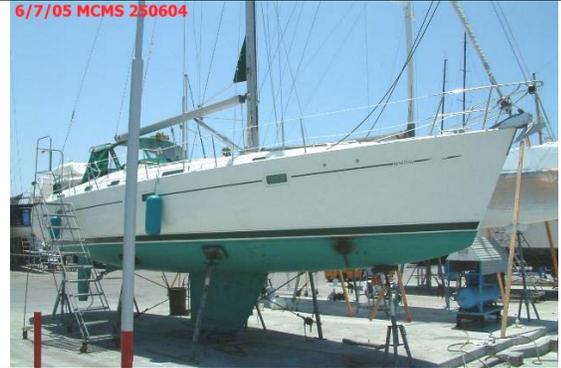
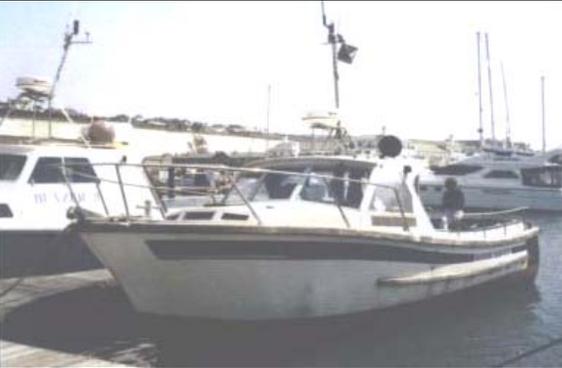
<p>Sailboat Located in southern California</p>	<p><i>RANDOM HARVEST</i> Located in England</p>

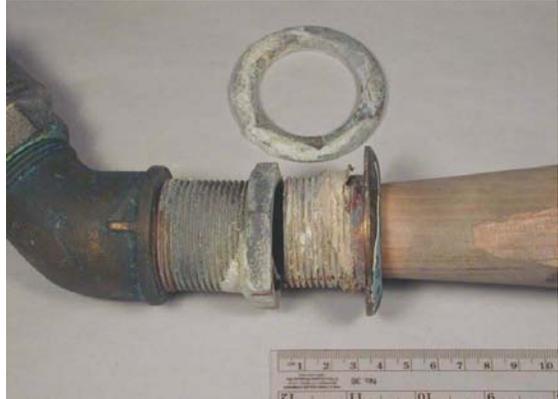
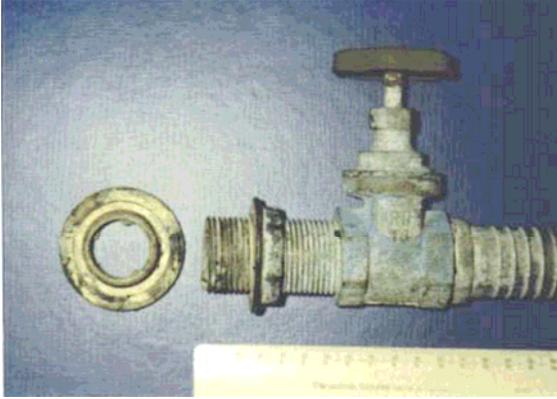
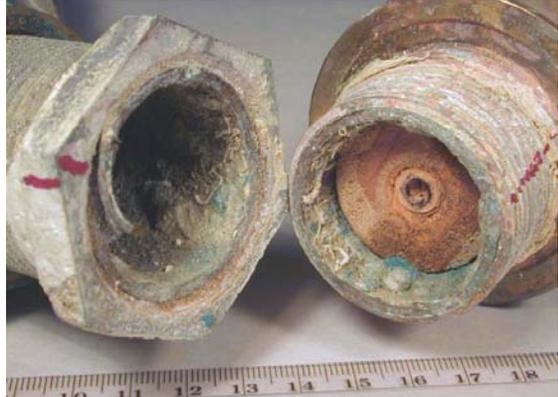
Head discharge assembly	Head inlet assembly
Not Bonded	Bonded
Time in Service - 7 years	Time in Service - 16 months
No Backing Block on FRP	Backing Block on FRP
Not stressed from over-tightening	Stressed from over-tightening
Original fitting with new boat	Owner purchased replacement fitting

Fitting alloy composition as determined by laboratory testing Brass 60/40		Fitting is Tonval® Cu 59 <i>The alloy composition of Tonval® is listed from an Italian website⁵</i>	
55.61%	Copper	Copper	59.00 to 60.00%
38.20%	Zinc	Zinc	34.42 to 38.70%
2.71%	Aluminum	Aluminum	0.50 to 0.08%
1.80%	Lead	Lead	1.80 to 2.50%
1.07%	Ferrous (Iron)	Ferrous (Iron)	Max. 0.80%
0.61%	Silicon	Silicon	Max. 0.05%
		Tin	Max. 0.80%
		Nickel	Max. 1.20%
		Manganese	Max. 0.15%

The thru-hull fitting on the sailboat did not have a backing block in place. Without a backing block of wood, the potential for over-tightening and stressing the threads is higher when trying to snug against the hard surfaces of FRP. Although *RANDOM HARVEST* did have a backing block, one of the findings was that the thru-hull failed from stress-corrosion cracking resultant to over-tightening.

Sailboat: The boat owner (who is the original owner of the vessel) also reported that the other (forward) head discharge thru-hull fitting failed about three years earlier (without flooding the boat or becoming a claim). The failed fitting is the aft head discharge.

RANDOM HARVEST: Within the MAIB report, we are advised that both the head inlet and discharge thru-hull fittings were changed approximately 16 months before the inlet fitting failed. Both the inlet and discharge fittings were removed following the loss, and both were tested. The discharge thru-hull fitting was also Tonval® and it was also heavily dezincified, it just had not yet started to leak.

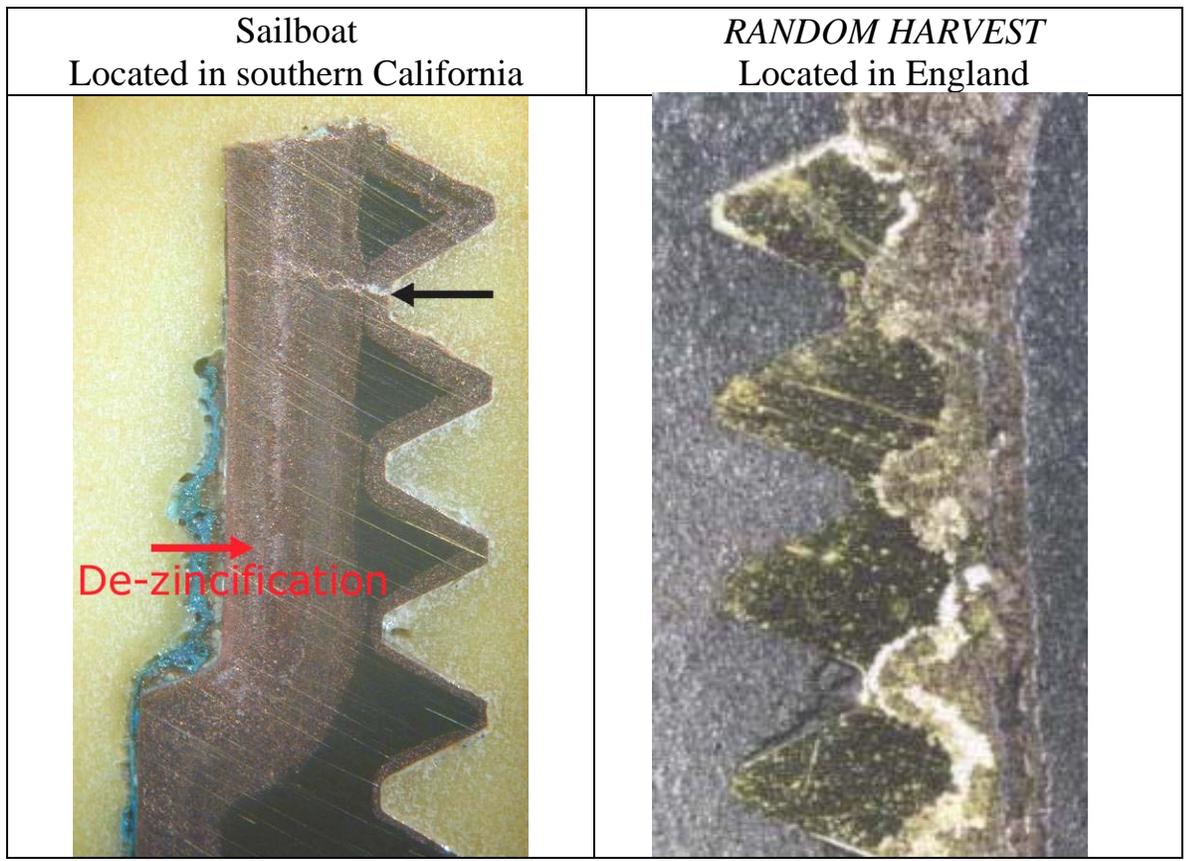
These are magnified photos of the threaded portion of each thru-hull. The sailboat fitting shows dezincification from the wet side and dry side. The only portions that are not dezincified are the small dark triangles within each thread. The black arrow indicates a crack and incipient failure. The fracture is at the top of the sailboat photo.

The dezincification on the *RANDOM HARVEST* sample has taken a different form, as it appears to be on the wet side only. The *RANDOM HARVEST* failure occurred within 16 months, whereas the sailboat fitting dezincification took place over 7 years.

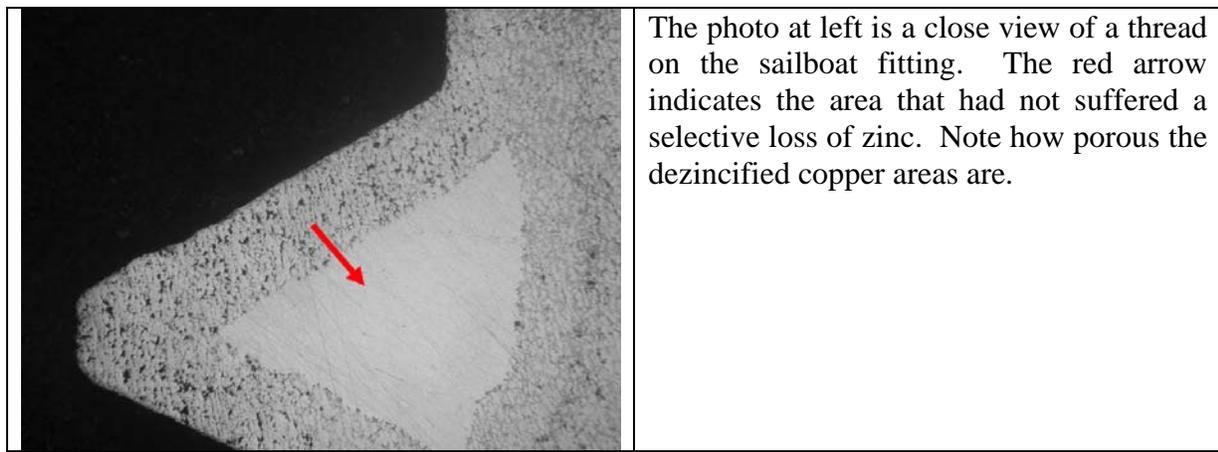
An analysis of the various parts of the failed sailboat fitting was undertaken. Deposits on the interior and exterior thread surfaces of the fitting were analyzed and two areas of the fractured face were analyzed. Here are the results:

Original Alloy	Deposits on Inside and Outside of Fitting		Dezincified Area Analysis	
		Thread Deposit	Inner Deposit	Fracture Face Sample 1	Fracture Face Sample 2
Copper	55.61%	1.59%	4.58%	68.78%	78.24%
Zinc	38.20%	72.72%	47.86%	10.09%	15.35%
Aluminum	2.71%	1.31%	0.71%	0.55%	0.52%
Lead	1.80%	5.70%	5.91%	8.44%	1.50%
Ferrous (Iron)	1.07%	0.35%	1.09%	1.20%	1.25%
Silicon	0.61%	1.24%	1.54%	0.39%	0.20%
Chlorine		17.09%	6.26%	1.25%	2.04%
*Carbon			28.37%	7.71%	
Calcium			2.02%		
Cadmium			0.89%		
Titanium			0.77%		
Tin				1.59%	0.90%
	100.00%	100.00%	100.00%	100.00%	100.00%

*Carbon is from bottom paint that was coating the inside of the thru-hull fitting.
